***Deer Island Power Outage
March 14, 2018***

March 14, 2018: Deer Island Power Outage

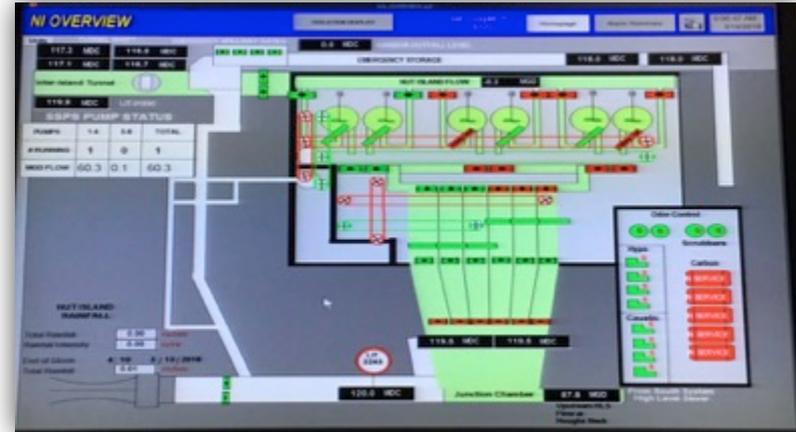
- **8:37 am: Eversource regional outage**
 - Fault at South Boston, Andrew Square
 - Affected all water and wastewater facilities in the area
 - Deer Island only facility to trip off line
- **9:00 am: First pumps on-line**
 - Flow ramped up over next hour
 - Close coordination with Chelsea OCC required
- **No SSOs, CSOs or any raw sewage releases as a result**

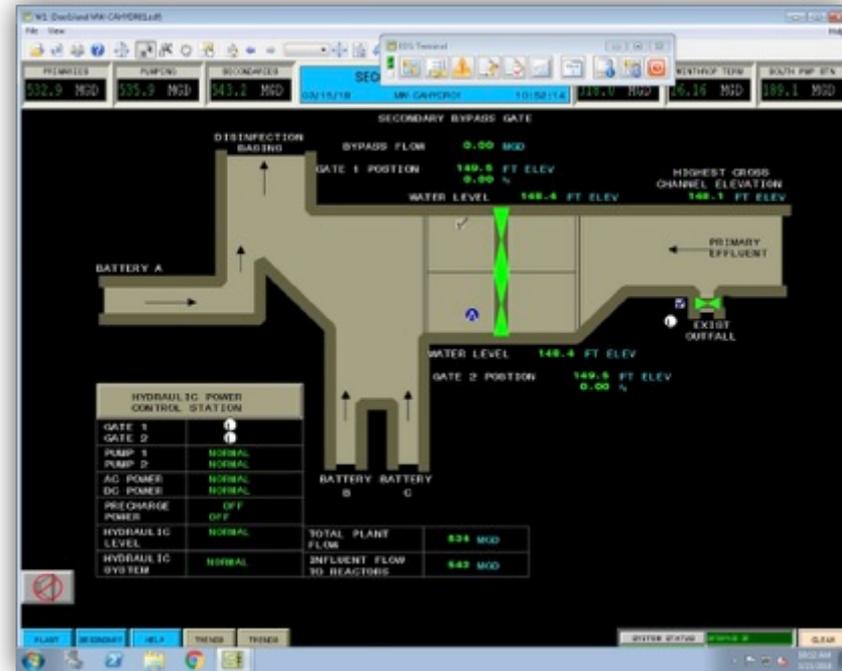
Flow Control Gate (controls blended flow quantities)

Reportable event due to Blending / Bypass occurring at less than 700 MGD

- 9.74 Mgal out of 551 Mgal for Day
- Less than 2% of Total Plant Flow Blended or Bypassed
- All NPDES permit numerical standards met

- HMI graphic revised
- Changed Authorization – only Shift Managers or Higher have authorization to adjust set points effective immediately
- Added alarms whenever gates are not in upright closed position
- Tool Box Talks conducted for all Operations Staff:
 - Importance of Gate
 - Impact to NPDES permit
